The Historic Trefethen Winery

Repair and Retrofit in the Aftermath of the Napa Earthquake

By Marianne Wilson, S.E., Kevin Zucco, S.E., and Brett Shields, P.E.

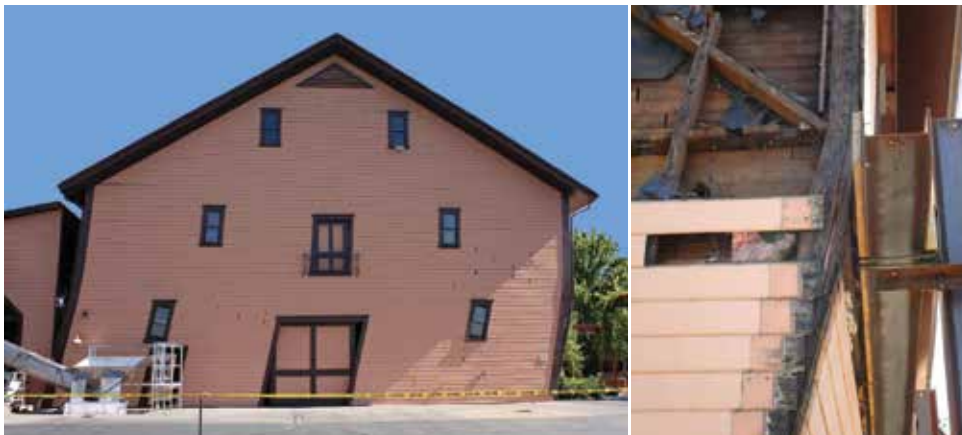
In the immediate aftermath of the 6.0 magnitude Napa earthquake on August 24, 2014, the historic structure rested in a precarious tilt with the second and third story shifted approximately four feet to the west (Figure 2). Nearby ground motion readings indicate spectral accelerations ranged from 0.4g to 1.7g for low-period, one- to two-story wood framed structures. The largest deflection occurred at the North end of the second-floor level where water-filled tanks and barrels were stored at the time. The filled water tanks constituted a large concentrated mass at the northern end of the second floor, increasing the seismic forces acting in this area where the larger localized horizontal deflections occurred.

With the potential for total building collapse an aftershock away, steel shoring and cribbing were immediately erected to prevent further offset and to support displaced gravity members. The timber-framed gravity system was constructed without positive connection between posts and beams, or posts and foundations, allowing posts at the

Figure 2. Post-earthquake deflection and localized damage at second-floor level.

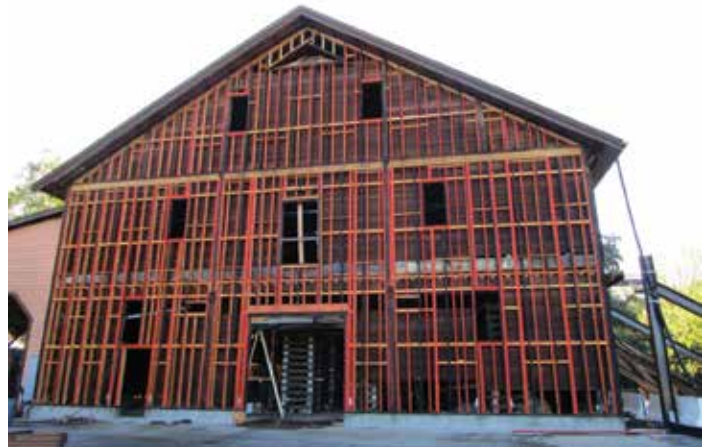
Figure 5. Retrofitted gable end wall framing.

While the existing straight sheathing at the exterior of the structure would have been adequate to resist historical building code lateral loading for most locations, plywood shear walls added to the full exterior increase the structure's seismic capacity and resiliency. To preserve the more unique and fragile interior redwood siding, temporary removal of the exterior, straight sheathing, which suffered significant damage in the earthquake, allowed for installation of new plywood. Additional wall framing members were added to complete the load path for out-of-plane forces and provide minimum stud spacing for the new shear walls (Figure 5). Full height Laminated Strand Lumber (LSL) studs accommodate the stud length required at gable end walls. As an added benefit to exposing the wall framing, rigid insulation was installed improving the energy performance of the structure. The straight sheathing was painstakingly labeled before removal for refurbishment to ensure accurate reinstallation, to maintain the correct historic aesthetic at the exterior, and trim elements within the window openings were coordinated with the historical architect to accommodate the additional 1/2-inch wall thickness.
